COE CST Second Annual Technical Meeting: Fracture Mechanics of Sapphire for High Temperature Pressure Transducers

**Justin Collins
Advisor: William Oates**

10/31/2012

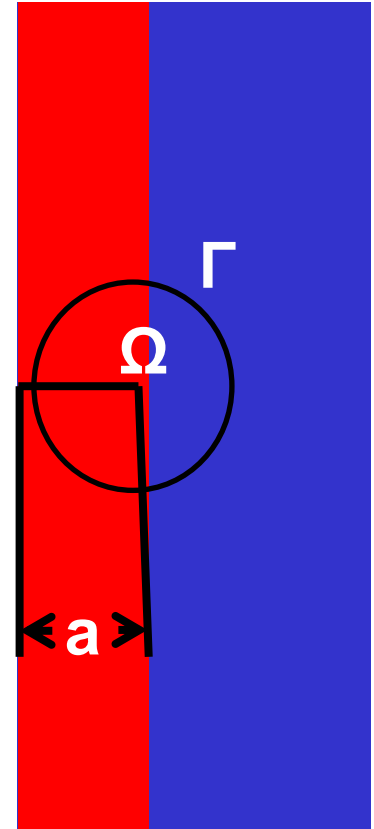
Theoretical Fracture Analysis

Eshelby stress tensor

J-Integral

When this condition occurs a crack propagates.
