Fracture Mechanics of Sapphire for High Temperature Pressure Transducers

Justin Collins

Department of Mechanical Engineering
Florida A&M / Florida State University
Tallahassee, FL 32310

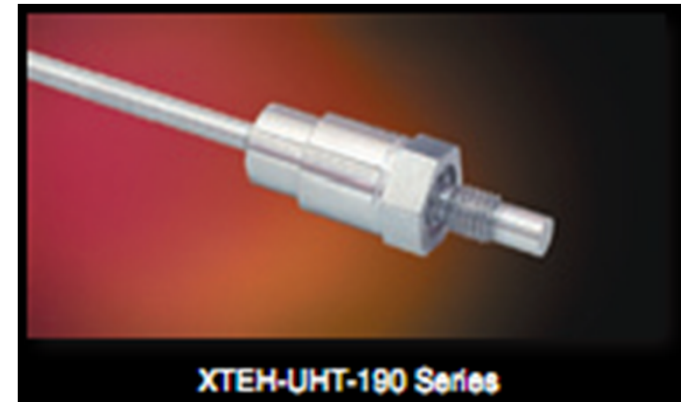
Kulite Pressure Transducer

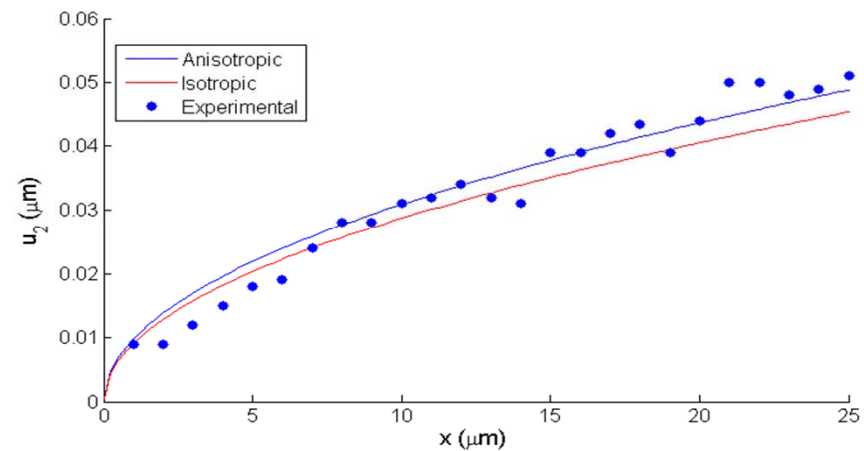
- $K_{1c} \cong 2.3 \text{ MPa}\cdot\text{m}^{1/2}$
- $G_c \cong 11.65 \text{ N/m}$
- $K_{1c} \cong 2.65 \text{ MPa}\cdot\text{m}^{1/2}$
- $G_c \cong 16.22 \text{ N/m}$

Indentation at $\sim 45^\circ$

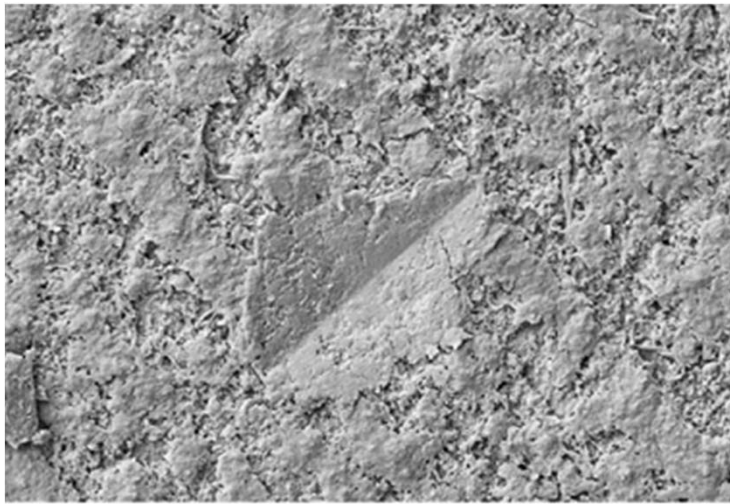
- ▶ Preliminary Vicker's indentation characterization
- ▶ No visible cracks
- ▶ Laser machining parameters
 - 10 kHz rep rate, 10 mm/s scanning speed, 3.8 J/cm² fluence, 3um stepover

- ▶ Correlated crystal structure with anisotropic elastic properties
- ▶ Quantified crack tip toughness in virgin sapphire specimens
 - Good correlation with data in literature
- ▶ Laser machining effects on fracture
 - Unusual toughness enhancement
- ▶ Hypothesis: Laser induced dislocations
 - TEM characterization and dislocation/fracture modeling currently underway
