PROCESSING AND CHARACTERIZATION OF BASALT FIBER REINFORCED CERAMIC COMPOSITES FOR HIGH TEMPERATURE APPLICATIONS USING POLYMER PRECURSORS

Sarah B. Cox, Donovan Lui, Xin Wang, Jihua Gou
Department of Mechanical and Aerospace Engineering
University of Central Florida
Orlando, FL, 32816

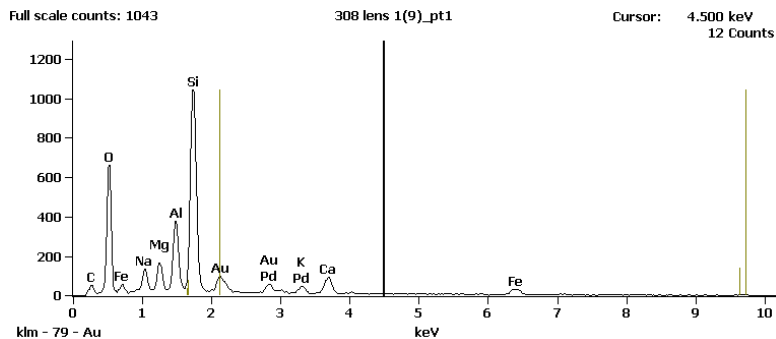
Figure 6. EDS from Polycarbosilane Panel (LBF225)

Figure 5 and Figure 6 are SEM and EDS, respectively, from polycarbosilane panels which were pyrolyzed to 700 °C and had 2 reinfiltration cycles. The SEM image shows very few voids in the matrix surrounding the fibers. Because these panels are only pyrolyzed to 700 °C, the matrix contains silicon, carbon, and oxygen; the other elements present are due to the basalt fiber.

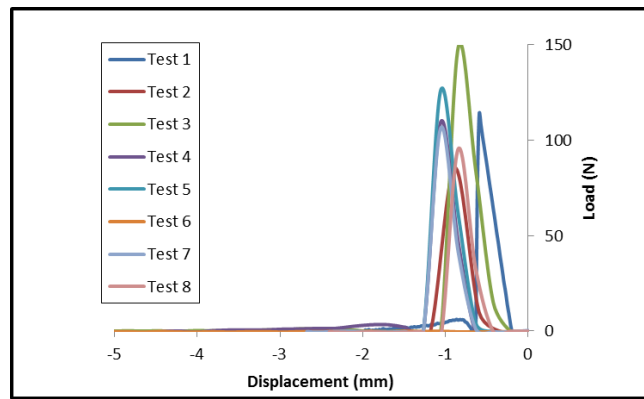
Figure 7. Displacement vs. Load for Test Panel #1

Two panels were fabricated and cut into specimens for bend testing, referencing ASTM C1341. This test is specifically for 3 and 4 point bending of continuous fiber reinforced ceramic composites. 3 point bending was performed on an Instron in the Mechanical Engineering Lab. The first panel tested only received one pyrolysis cycle and no reinfiltration (see Table 6). It was then cut into (8) 19 mm wide specimens. The specimens were 6 mm thick and they were tested at a span of 152 mm, which gives a thickness to span ratio of 24:1. The specimens were loaded at a rate of 0.041mm/min. Figure 7 shows the load vs. the displacement for all 8 specimens. There is

very little displacement before failure, which is common for ceramic materials. The fibers in the part allow for more flexure which increases the overall strength. Table 9 shows the flexural strength in each specimen; the average flexural strength was 33.5 MPa.

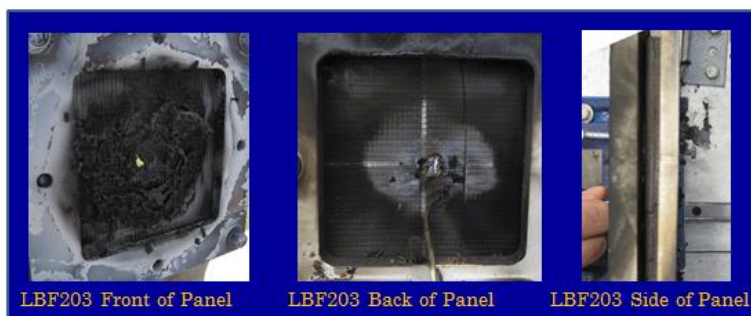
Figure 13. Panel LBF203 Post Test

Figure 12 shows the results for the first set of polycarbosilane panels, which had only one pyrolysis cycle and no reinfiltration. Only one of the five panels tested burned through; it took 40 seconds and reached a backface temperature of 500°C. The other panels were tested until the adhesive holding on the thermocouple melted. Because these panels were slightly bowed, there may have been heat intruding between the metal frame and the panel, which allowed the heat to the back of the panel from the sides. Also, because the panels bowed outward, the impingement point was slightly closer than 3/4" which may have changed the heat flux seen by the front of the panel. Even with the early termination, the testing continued for 40-60 seconds, lasting longer than the polysiloxane panels. Figure 13 shows the panel which did burn through. These panels cracked through the thickness very early into the test (can be seen in the back face and side views), and the ablation appears to be slightly different than what was seen with the polysiloxane panels. This is most likely due to the bowing in the panel.
